Heavy Gauge Corrugated Frameless Panels

Available in Galvanized | Galvalume™ | Pre-coat | Stainless Steel | Factory Applied Custom Colours

BEHLEN
Made Strong

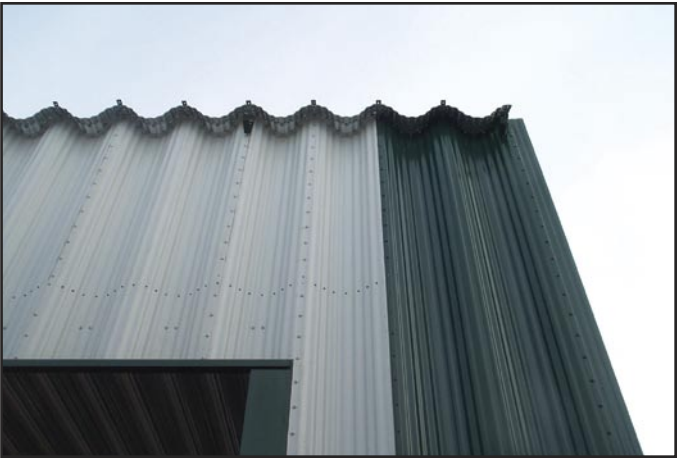
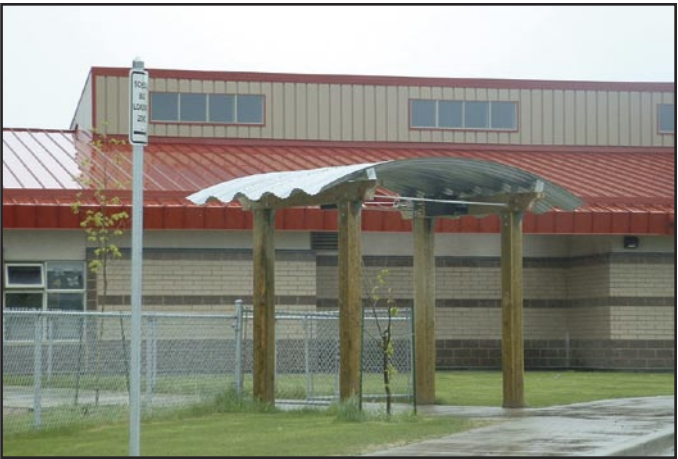
4 1/2" CORRUGATION

The support strength of a BEHLEN corrugated panel can equal that of a steel girder of the same length and weight. The strength lies in our exclusive "compound" corrugation process which rolls sheet steel into 4 1/2" or 7 1/2" deep corrugations embedded with a series of smaller corrugations. These small corrugations enhance the strength achieved with normal corrugation.
